# Manhole Inspection Summary

Manhole # S37EE\_001MH

Insp Date: **3/22/07 9:42 AM**

**Location** Address: **1200 BRENTWOOD AVE**

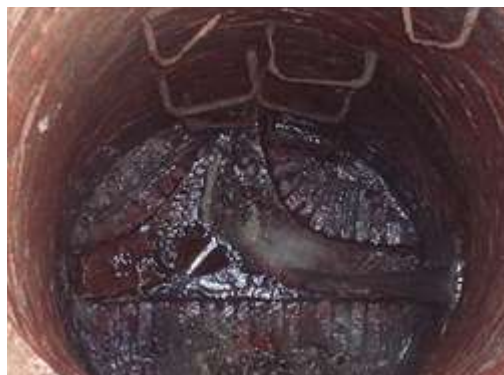
Top View

Corroded and missing steps. Bench debris.

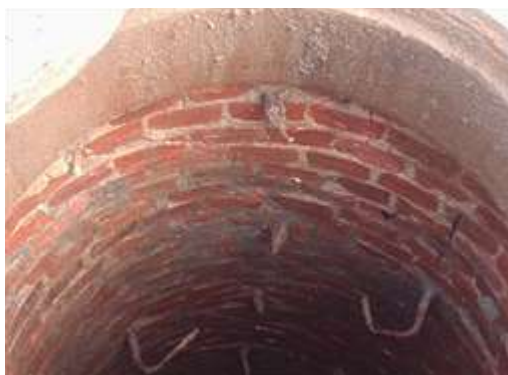
Defect

Frame leaks. Adjustment deterioration, cracks and infiltration. Corbel infiltration.

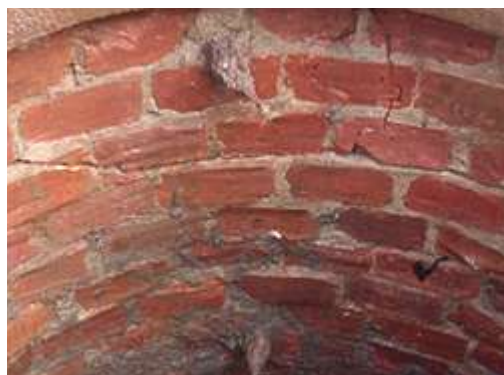
Defect

Frame leaks. Adjustment and Corbel deterioration, cracks and infiltration.

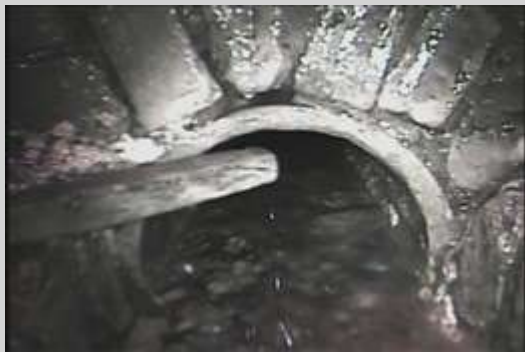
### 8 in. Circular Gravity Sewer Pipe Out @ 12 O'Clock

Barrel deterioration and infiltration. Channel deterioration.

Deposits: ☐ None ☐ Mud ☐ Sludge ☐ Debris ☒ **Grease**

Infiltration: **None** Pipe Seal Cond: **Broken**

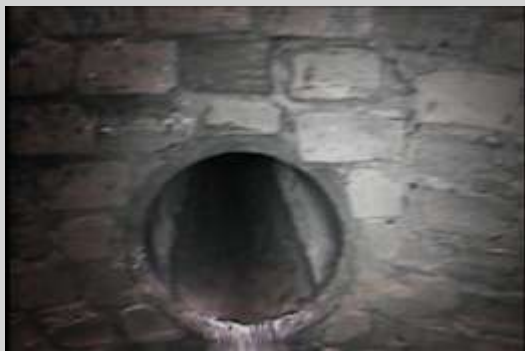
### 8 in. Circular Gravity Sewer Pipe In @ 3 O'Clock

Barrel deterioration and infiltration.

Infiltration: **Evidence** Pipe Seal Cond: **Unknown**

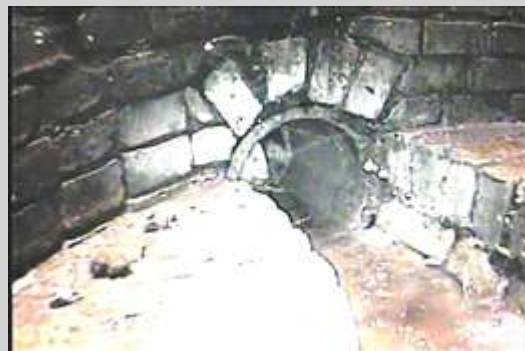
### Drop In @ 3 O'Clock

Barrel deterioration and infiltration.

Drop Condition: **Clogged**

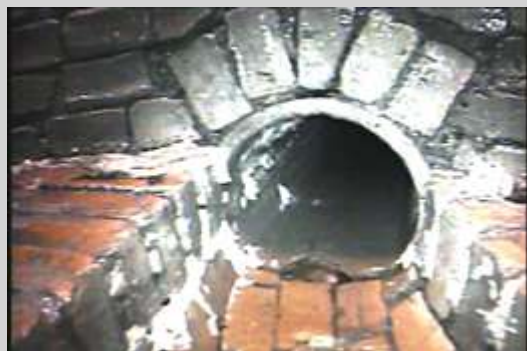
Pipe In @ 9 O'Clock

Barrel deterioration and infiltration. Channel deterioration.

Deposits: ☐ None ☐ Mud ☐ Sludge ☐ Debris ☒ **Grease**

Infiltration: **Evidence**
